Leakage reduction in primary schools

Upington, South Africa

Project Overview

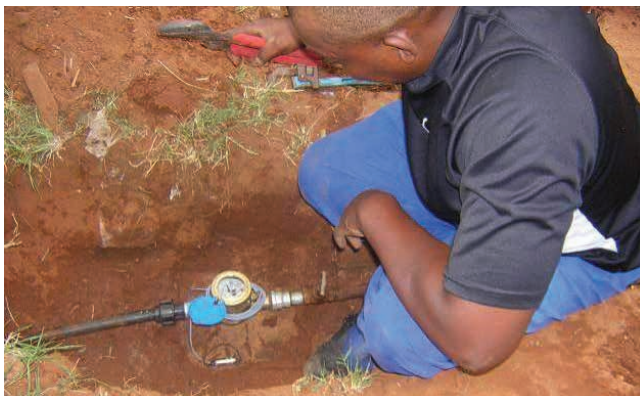
Above: Installation of a loggable consumer meter (© WRP (pty) Ltd.)

The first step involved installing loggable meters at the Keidebees and Vela-Langa primary schools. Loggers were installed on the new meters to monitor the consumption patterns at the schools prior, during and after the leak repair exercise. Flows in m³/hr were monitored for one week before carrying out the required repairs. Most significantly, the average minimum night flows were measured at 2.1m³/hr and 1.1m³/hr at the two schools, indicating that leakage rates were excessively high. After the repairs the average minimum night flows were reduced to 0.7m³/hr and 0.4m³/hr respectively.
